COMPREHENSIVE MOTOR VEHICLE SERVICES & CONSULTING Motor Vehicle Forensic Analysis Report

People of the State of New York v.
Nauman Hussain

REFERENCED INVOLVED SUBJECT VEHICLE: 2001 Ford Excursion Stretch Limousine,
VIN 1FMNU40S51EB10299

MOTOR VEHICLE AUTOPSY FORENSIC INVESTIGATION SUMMARY

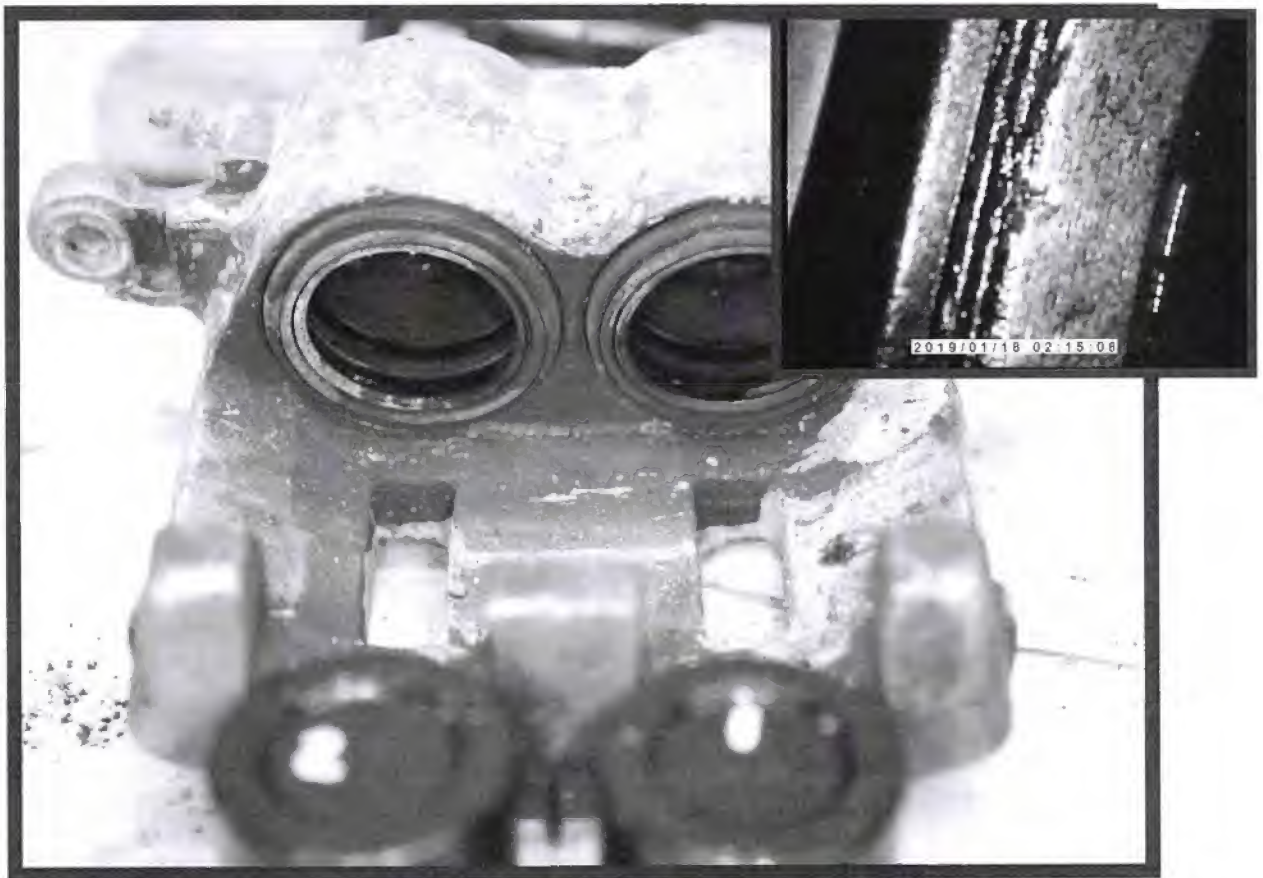
Image No.36. This photograph depicts the right front disc brake caliper of the 2001 Ford Excursion stretch limousine during the period of individual component analysis, following removal of the caliper pistons to allow for examination of the pistons, caliper body bores, and piston seals. As with all front braking system components, the effects of severe thermal distress were clearly evident -- including the intense pungent odor of burnt materials/components.

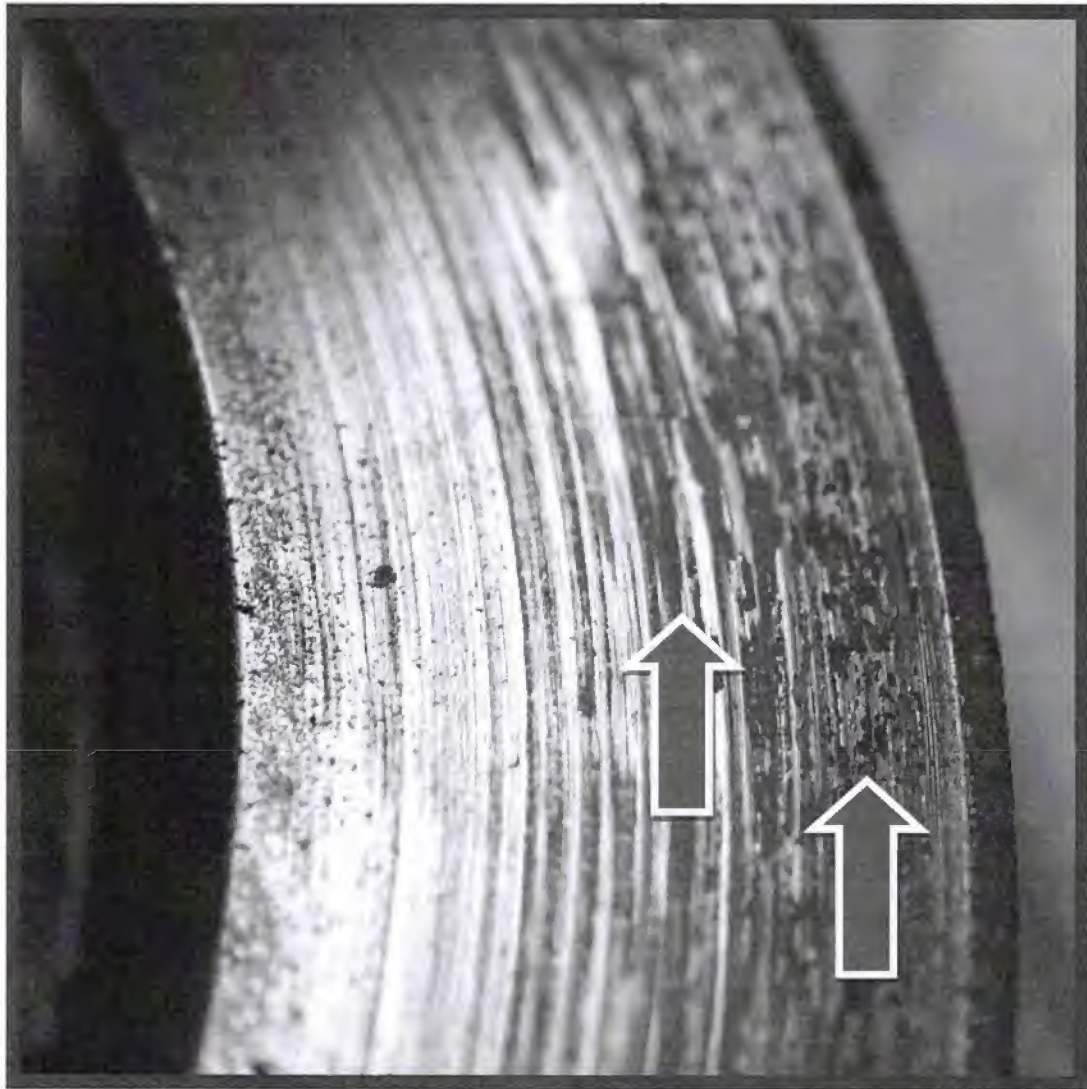
Image No.37. This photograph depicts the outer swept area of the right front disc brake rotor of the 2001 Ford Excursion stretch limousine during the period of individual component analysis. As with all front braking system components, the effects of severe thermal distress were clearly evident, including embedded material consistent with thermal deterioration of disc brake pad friction material during braking (Red Arrows).

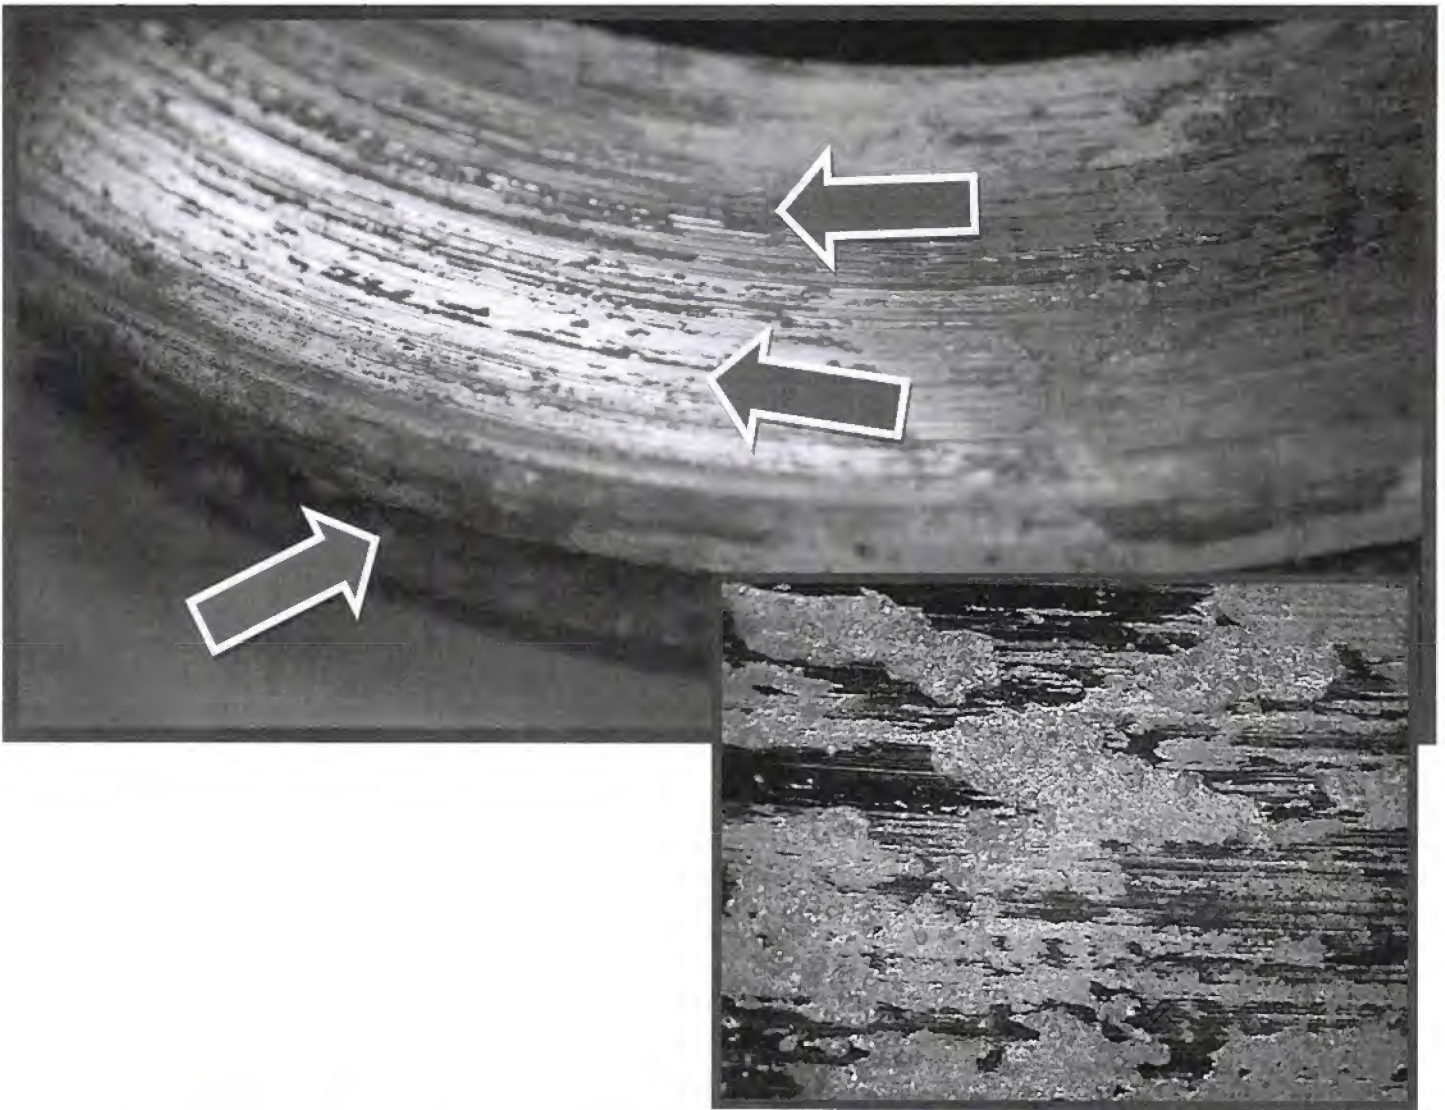
Image No.38. This photograph, with Digital Microscope image insert, depicts the inner swept area of the right front disc brake rotor of the 2001 Ford Excursion stretch limousine during the period of individual component analysis. The effects of severe thermal distress from braking were clearly evident - the Red Arrows denote areas of embedded material consistent. The significant corrosion present at the vent area vanes resulted in a reduction in thermal energy transfer (Blue Arrow).

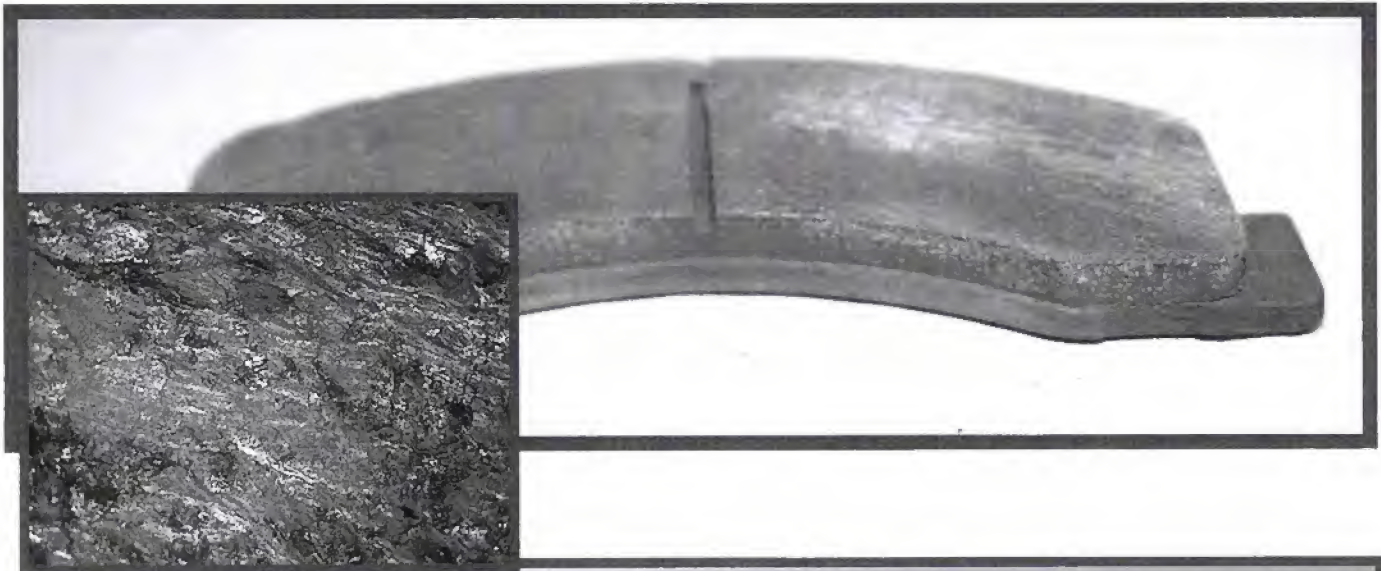
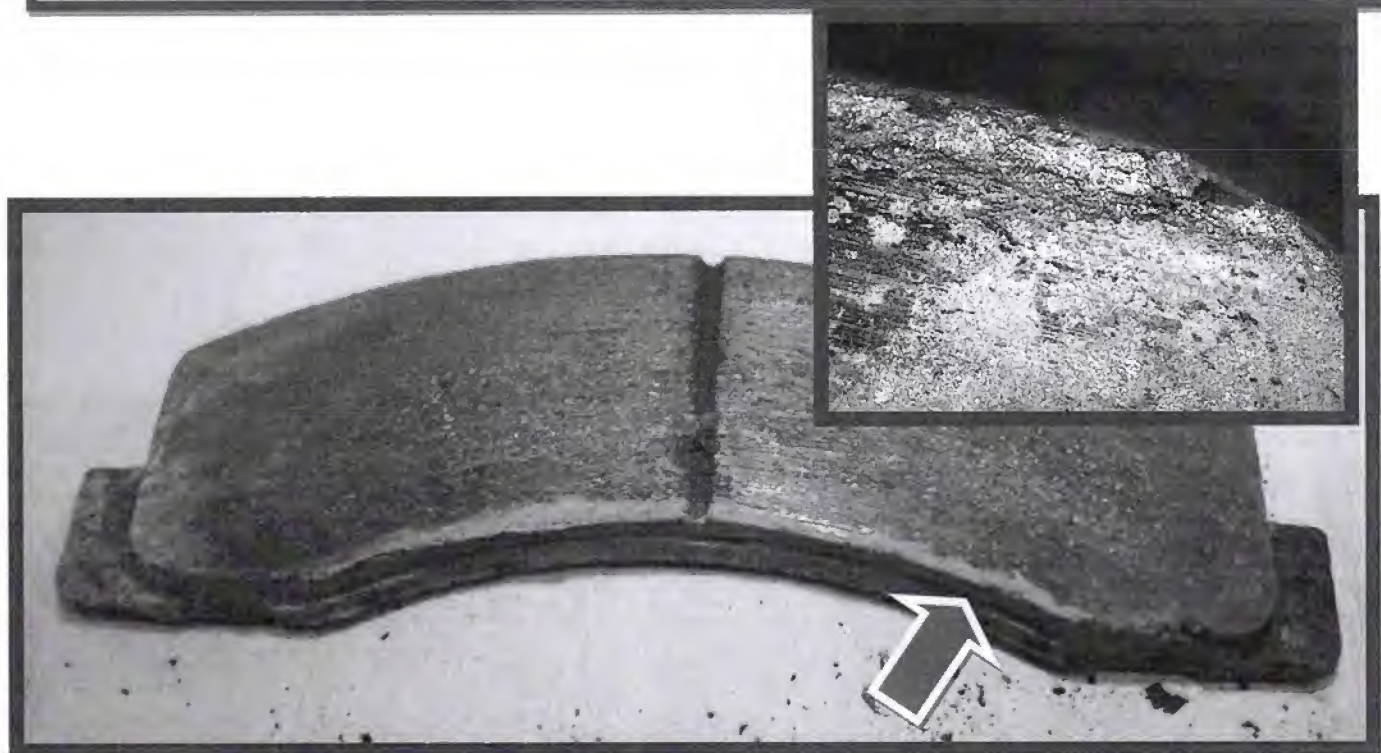
- ✓ Digital measurements of friction material thicknesses of outer disc brake pad 0.314" - 0.348". Original friction material 0.443". Corrosion present at abutment clip locations.

Images No.39a & 39b. These photographs, with Digital Microscope image inserts, depict the outer disc brake pad friction material (above photographs) and the inner disc brake pad friction material (below photographs) of the right front disc brake pads of the 2001 Ford Excursion stretch limousine during the period of individual component analysis. As with all front braking system components, the effects of severe thermal distress were clearly evident, including delamination and glazing as denoted by the insert photographs. The Red Arrow depicts separation of the bonded friction material from the steel foundation of the disc brake pad, consistent with extreme temperatures from braking.

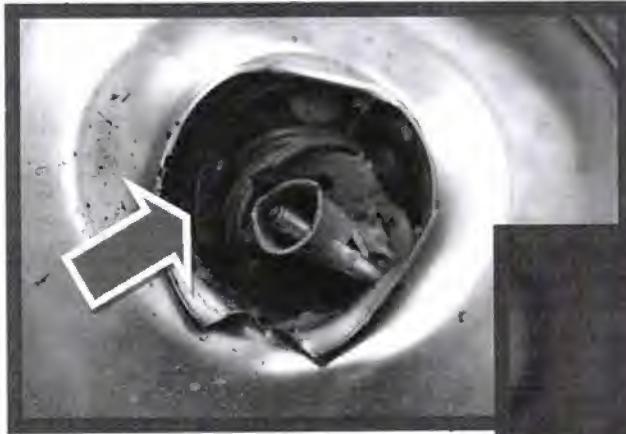
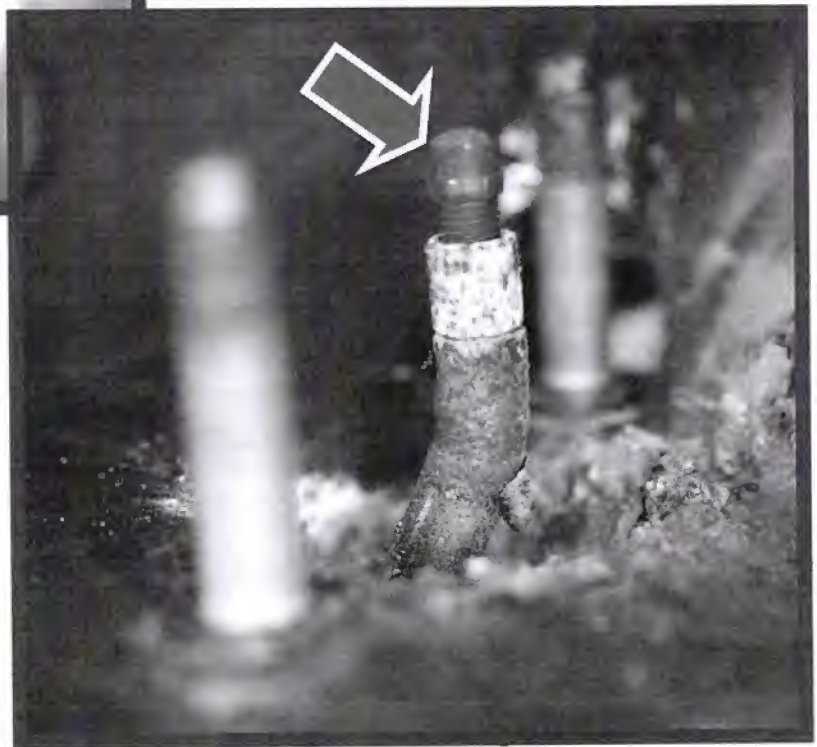
Image No.41a & 41b. These photographs depict the brake master cylinder push rod (lower photograph) and the power brake vacuum booster of the 2001 Ford Excursion stretch limousine during the period of individual component analysis. The state of compression of the internal power brake vacuum booster (Red Arrow), and the extended position of the brake master cylinder push rod of the power brake vacuum booster (Blue Arrow), are consistent with that of brake pedal depression by the vehicle operator at the time of impact, which seized the components in position.

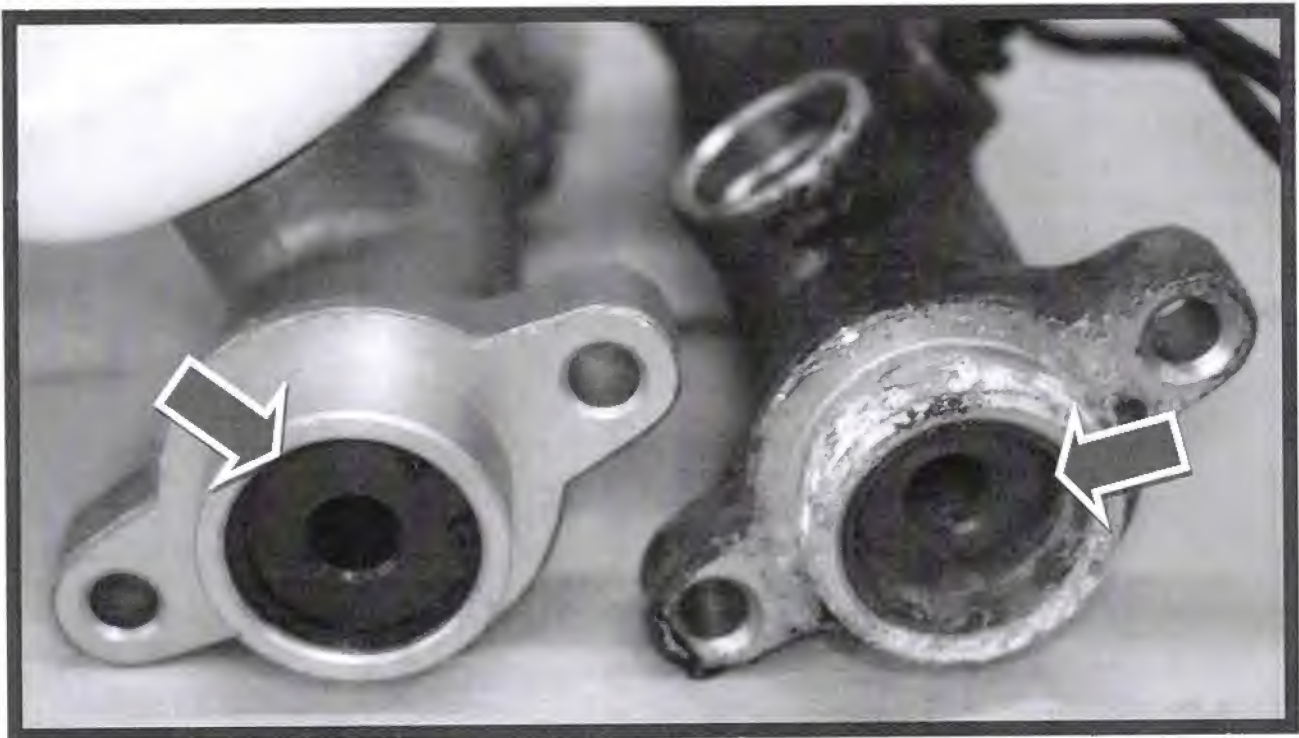
Image No.42. This photograph depicts the brake master cylinder of the 2001 Ford Excursion stretch limousine during the period of individual component analysis (photo right), compared to a new replacement brake master cylinder of the same manufacturer and part number (photo left). The state of seized compression of the primary piston of the involved vehicle brake master cylinder is denoted by the Red Arrow, while the normal spring extended primary piston state is denoted by the Blue Arrow. This post crash condition is further consistent with that of brake pedal depression by the vehicle operator at the time of impact.

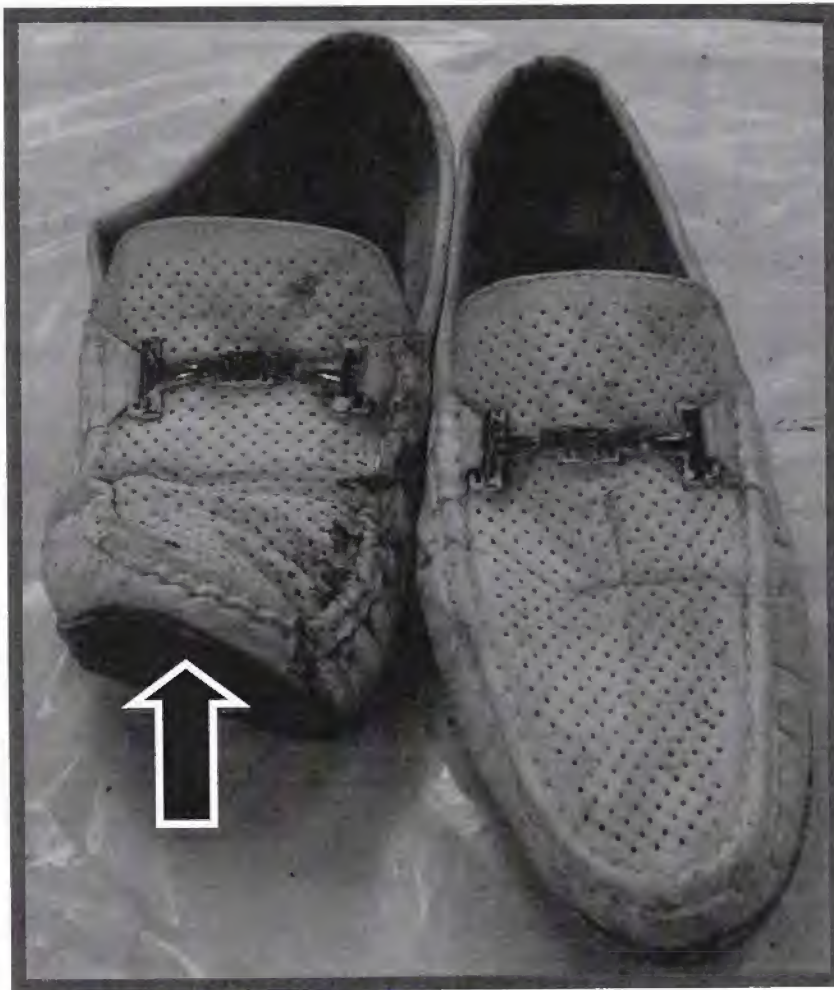
Image No.43. This photograph depicts the shoes worn by the operator of the 2001 Ford Excursion stretch limousine at the time of the crash on October 6, 2018 in Schoharie, New York. Note that one of the shoes exhibits remarkable deformation at the forward section (Black Arrow), consistent with that section of the foot providing brake pedal depression at impact.

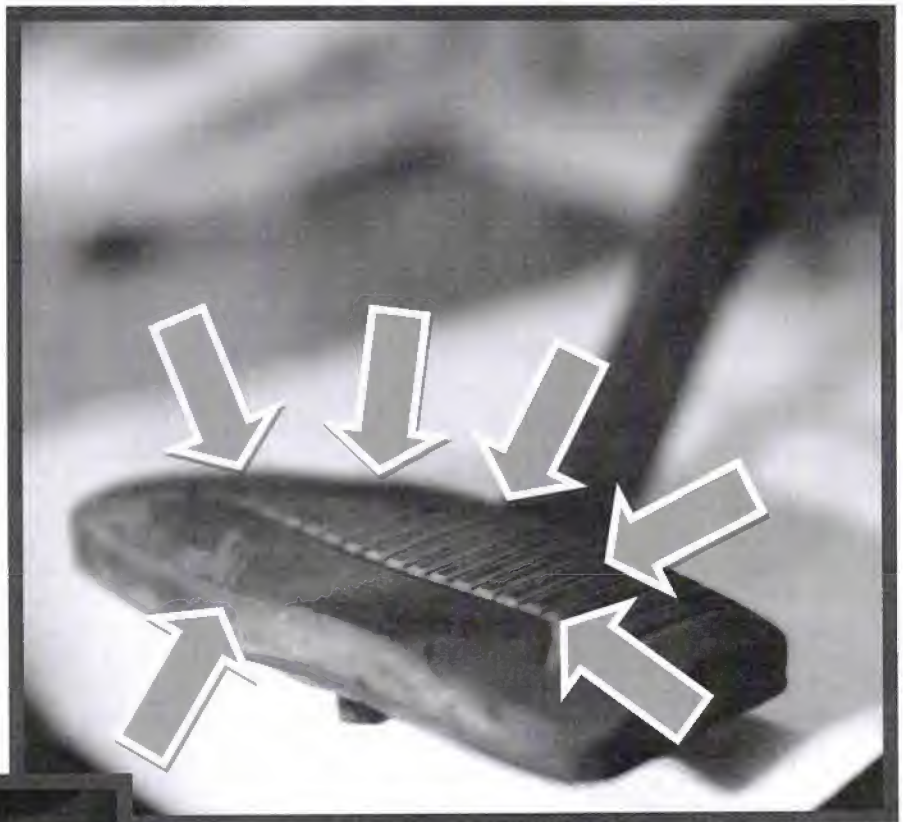
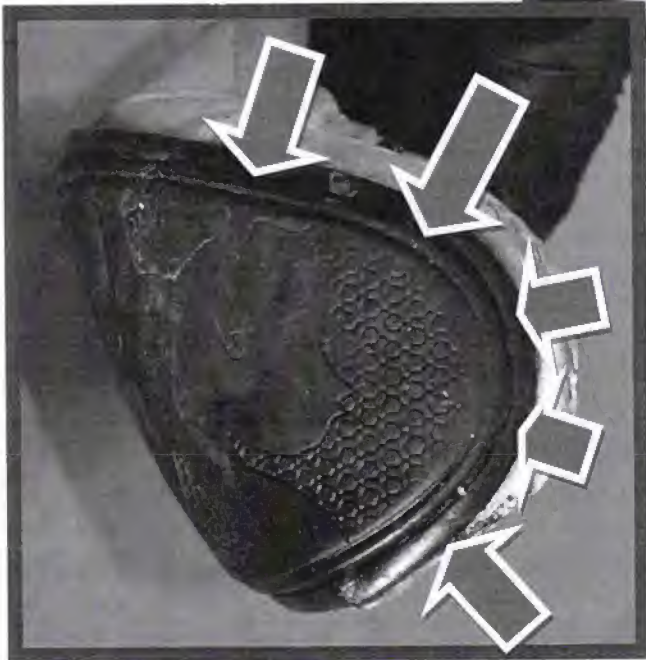
Image No.44a & 44b. These photographs depict the rubber composition brake pedal pad of the 2001 Ford Excursion stretch limousine during the period of individual component analysis (above photograph; and the shoe worn by the operator of the vehicle at the time of impact on October 6, 2018 in Schoharie, New York (left photograph). Note the semi-circular depression imprint of the brake pedal pad (Orange Arrows), which is consistent with the shape of the deformed shoe worn by the operator of the vehicle.
